Autoclave Scalding

Post-doc Scalded when using Tower-Style Autoclave

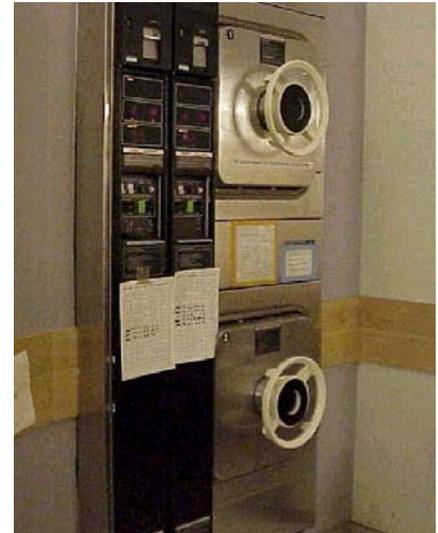
A postdoc, Dr. X, was scalded by water while removing items from the top autoclave of a tower-style autoclave. The autoclave was determined to be working properly at the time of the incident.

To autoclave her own materials, Dr. X began to remove a load that belonged to another laboratory while standing on a step-stool. The load in the autoclave consisted of a nalgene tub that contained liter bottles of media with water around them. The water in the tub was near boiling temperature as Dr. X attempted to remove it, and the contents spilled down the trunk and thighs of Dr. X. Another employee had gone to retrieve a cart so that the materials could be removed more safely.

1. Style/Model of the Autoclave: The tower style autoclave is more dangerous than a standard autoclave. Removing a load from the top autoclave requires standing on a step-stool or platform ladder and stepping down to place the load on a cart. For a short-statured person, a standard step stool is not high enough to allow them to remove a load without reaching over their head. (Note: A standard step stool was used in this incident.) In addition, the bottom autoclave is too low for a tall person to comfortably insert or remove loads.

4. Nalgene tubs were used instead of metal tubs: Dr. X indicated that the nalgene tub had buckled. The Nalgene tubs may get less sturdy as they age and may soften when exposed to intense heat.

The facility has appropriate platform ladders in place to allow individuals of different heights to reach the top autoclave. They are bulky, however, and personnel are probably more likely to use a step stool. Facility had not required that liquid loads be autoclaved in the bottom unit before the accident because of ergonomic considerations for tall people. However, since the accident, liquid loads are permitted only on the bottom.

a. The Health and Safety Office is exploring the possible use of a hydraulic cart that could be used to take tubs out of the autoclave without the need to bend down or climb a platform ladder.

e. The Health and Safety Office strongly recommends that tower- style autoclaves not be installed in any future buildings or renovations.
